JOINT HIGHWAY
RESEARCH PROJECT
JHRP-84-9

AN INVESTIGATION OF POTENTIAL
ENERGY CONSERVATION FOR
INDIANA DEPARTMENT OF
HIGHWAY BUILDINGS

Final Report

by
Gary R. Smith
Graduate Instructor in Research

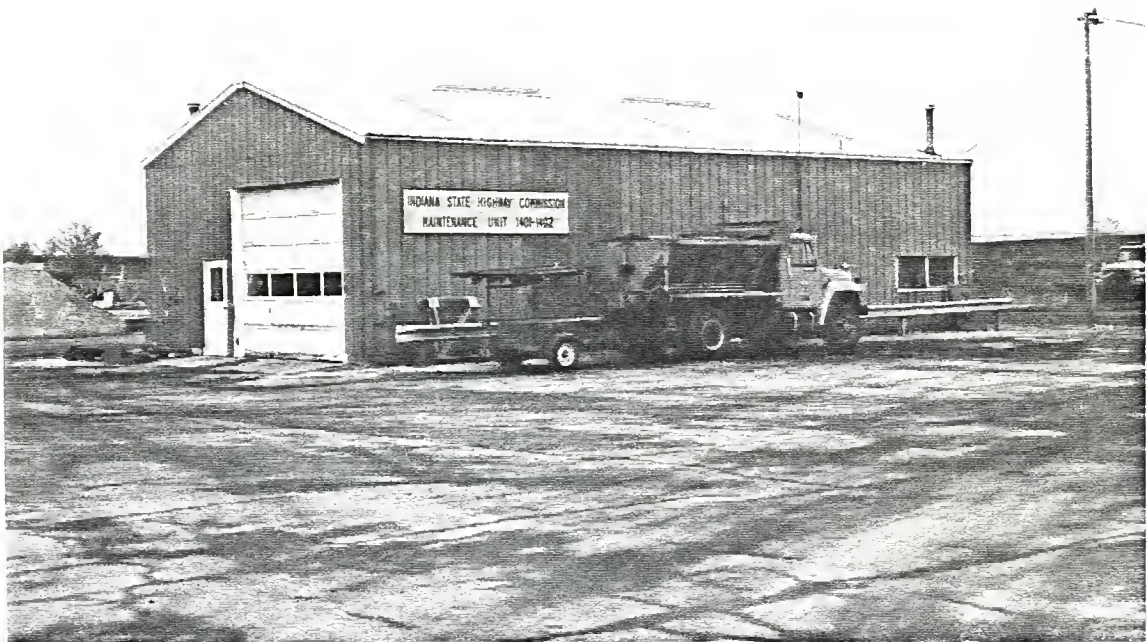
Figure 3.2 Building Type II

The comparison of the U-values for this structure and other existing structures should be explained in more detail. The code values as determined by ASHRAE were designed as an aid for new structure design and not for implementation on existing buildings. They are useful in this study as a guide in identifying areas of the structures that could be deficient in insulation value. The application of the code is acceptable as a guide only since many of the modifications proposed, to improve efficiency, do not necessarily bring the existing structure within the compliance guidelines. The comparison for the Type II Building is shown in Table 3.2.

The walls are the only area that seem to be within the

compliance figure. The roof and floor are deficient and will require further examination for possible corrective measures. The alternatives for the roof system will be discussed below. Very little can be done with respect to the floor system at this time.

There were several alternative measures examined for the roof. The primary idea was to reduce the heat loss and also reduce the conditioned volume to the minimum acceptable height. The installation of a drop ceiling would serve to increase the insulation quantity and also reduce the volume that needed to have heated air. There were several alternatives examined for this proposal which are as follows:

The other alternative for improving the roof insulation would be to devise a method of directly attaching insulation to the underside of the roof. Discussions with several field personnel indicated that this had been tried with various adhesives and none have been found to be acceptable. The existing insulation has been suspended from a light gage wire mesh. This method of installation can be utilized here again to support the insulation if necessary. The pay back period associated with this alternative is 4.6 years and would result in an estimated annual savings of \$761. The pay back period of this alternative is also beyond the 4 year target but it is closer to the target than the drop ceiling alternative.

1. The insulation existing in the building has several torn areas that should be mended or replaced.
2. The windows need to be caulked.
3. Some of the end seals for the exterior metal siding are missing or are about to fall out. They should be replaced or resealed.
4. There is a pipe placed through the exterior wall to permit hoses and other items to service the vehicles parked on the exterior. The pipe has no means of being sealed.

5. The existing man doors cannot be closed tightly and are in such a poor state that they should be replaced. This was not accounted for in the calculations noted above since this is a maintenance function.
 6. There was no evidence of photostatic controls for the exterior security lighting. Controls are recommended.
- The exact determination of which repairs and alternatives for these structures should be examined with regard for any phased plans being developed for their replacement. In the case that these buildings will be subject to replacement it could be possible to examine all the structures in the State and rank the replacements by the extent of repairs necessary to improve the overall efficiency of the structures.

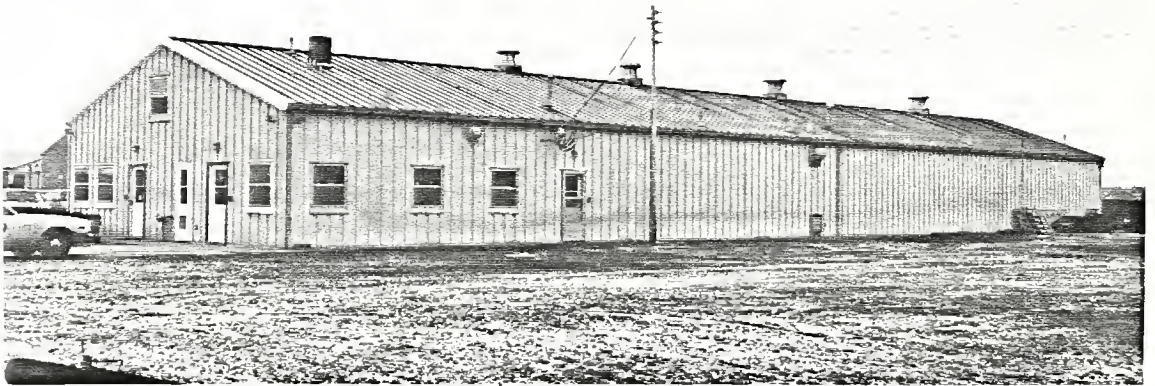
Figure 3.3 Building Type III

The Type III Building is similar in construction to the Type II Building. It is an all metal building constructed around 1965. The major exception is there is only one overhead door. The dimensions of the Type III Building are 160.5 feet by 40.0 feet. This structure is divided into two primary areas. The office and overhead storage area and the connected shop areas. The two areas have been treated as independent zones with the primary focus on the shop and sign storage areas. The particular structure that was audited for this study has had considerable alterations and

additions to the interior of the building. Offices that were added to the current sign storage area are essentially independent of the main building and are self contained with respect to energy consumption. The offices were constructed in a manner that would exceed the code requirements for insulation.

The current lighting system in this building would be sufficient if the decision would be made to cover the skylights. The only modification recommended for the lighting system is to eliminate some of the incandescent bulbs in a material storage room. The alternative examined for the overall lighting system is a change in the fluorescent

bulb type. The current bulbs require 75 watts per bulb. An energy efficient replacement for these requires only 60 watts per bulb. The pay back period is 3.9 years with the new bulbs and saves an estimated \$242 per year. The final recommendation for the lighting system is to install photocontrols on the exterior security lights.

The wood overhead garage door in the sign shop could be replaced with a new energy efficient door with perimeter door seal. The replacement door would save an estimated savings of \$280 per year. The pay back period for the door is 8.4 years which exceeds the target pay back of four years.

1. One of the unit heaters had rusted through on one side and needs to be replaced as soon as possible. Another

had been recently replaced. The possibility that a corrosive atmosphere may exist since the two units are both in the sign shop area.

2. Not all of the thermostats had lock box covers. One thermostat was not working properly.
3. The electric hot water heater has a 52 gallon capacity. A smaller capacity hot water heater that is energy efficient could probably serve occupant needs and reduce the energy costs for hot water.
4. Broken glass in doors and windows should be replaced and caulked.
5. Storm windows should be checked for tightness and minor adjustments made.
6. If the overhead garage door is not necessary the possibility of removing it or replacing with a smaller door should be investigated.

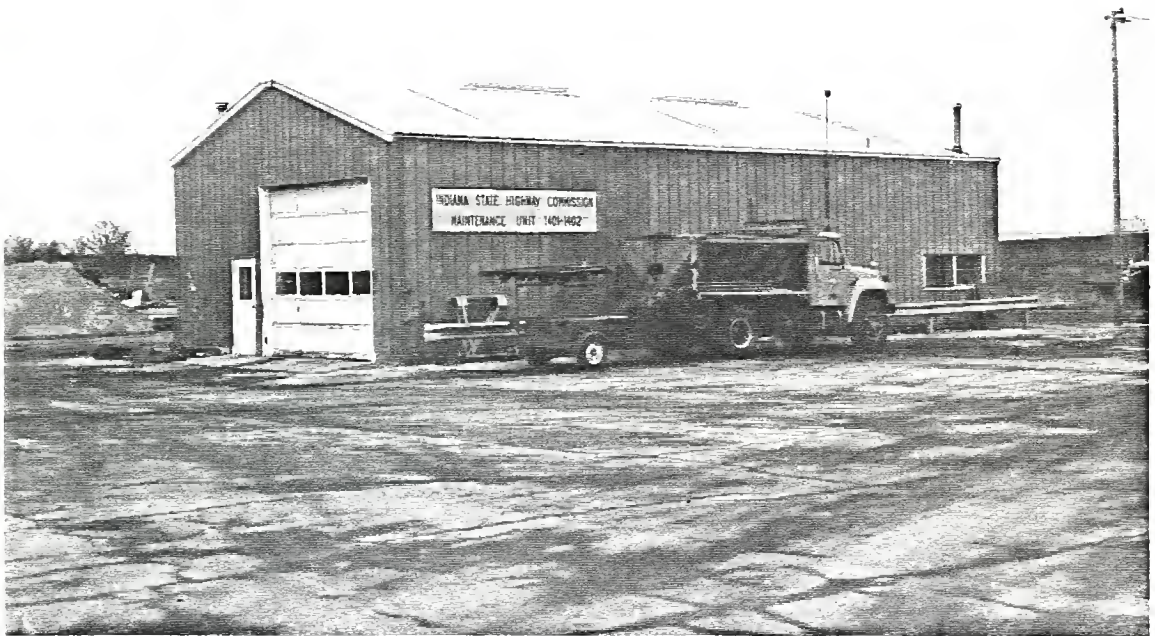
Building Type II: Small Metal Building

Frame	-	Steel frame construction with a gabled roof.
		Length: 63.5 feet
		Width: 30.0 feet
Roof	-	Galvanized metal roofing with two inches of insulation.
Wall	-	Galvanized corrugated metal siding with two inches of insulation.
Height	-	Peak height: 19 feet
		Gutterline height: 14 feet
Major Doors	-	One overhead door.
Use	-	Unit storage building.
Picture	-	One front view on the following page.

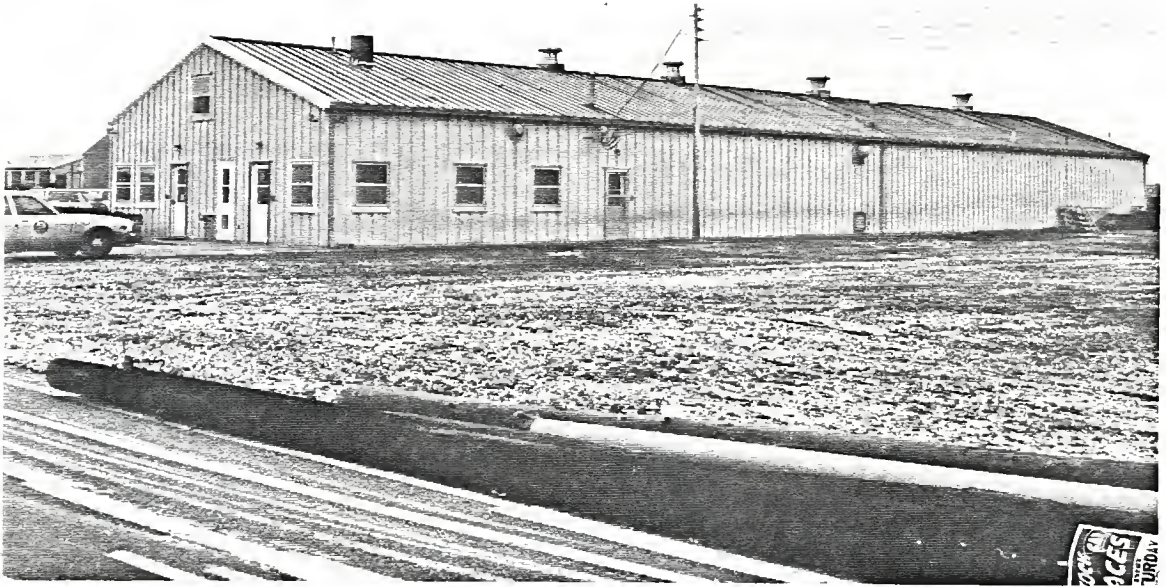
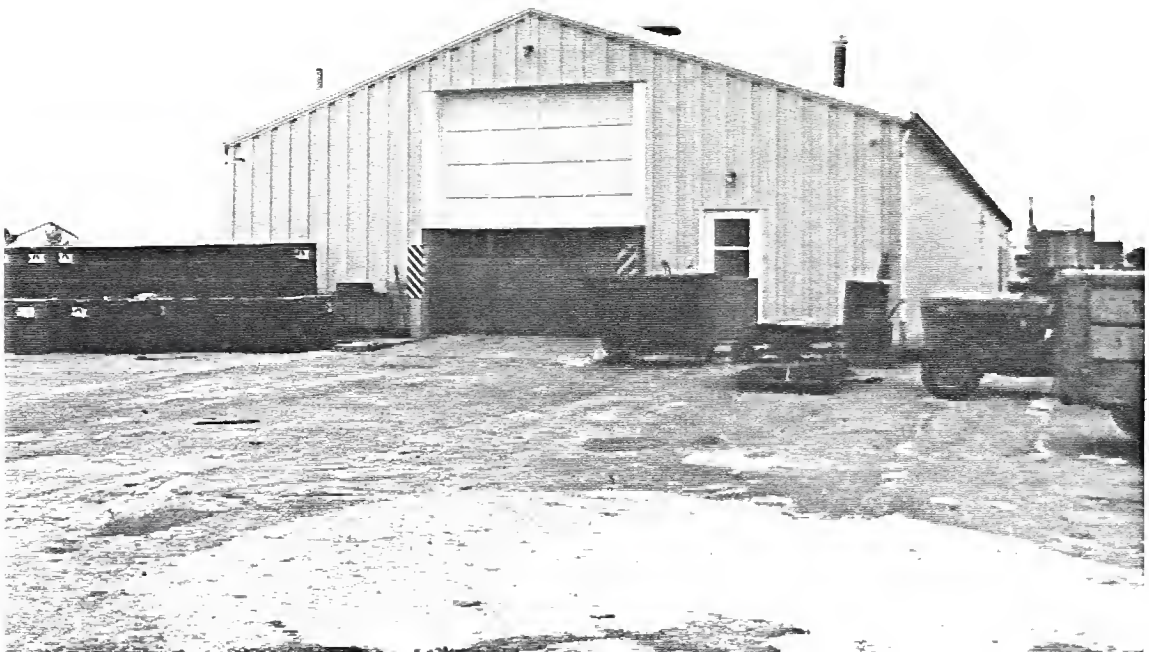
Building Type III: Large Metal Building

Frame	-	Steel frame construction with a gabled roof.
		Length: 160.5 feet
		Width: 40.0 feet
Roof	-	Galvanized metal roofing with two inches of insulation.
Wall	-	Galvanized metal siding with three inches of insulation.
Height	-	Peak height: 18.5 feet
		Gutterline height: 11.9 feet
Major Doors	-	One overhead door.
Use	-	Traffic operations building.
Picture	-	One front view and one back view on the following page.

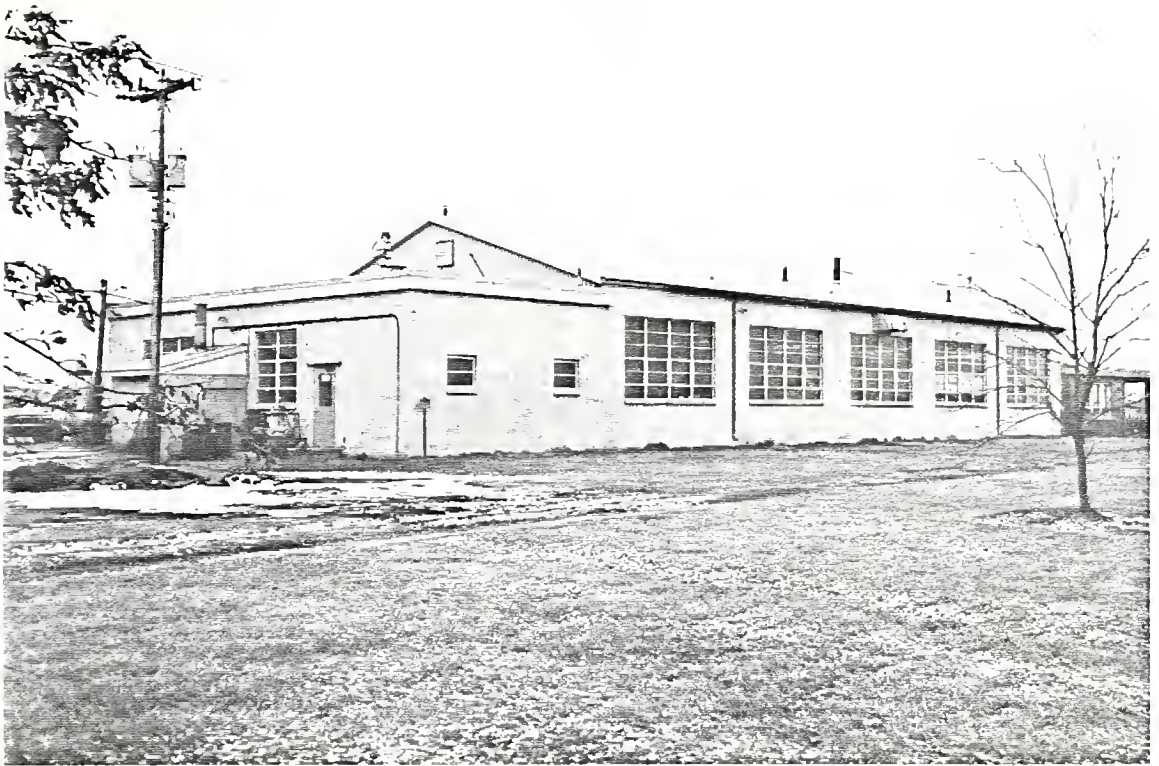
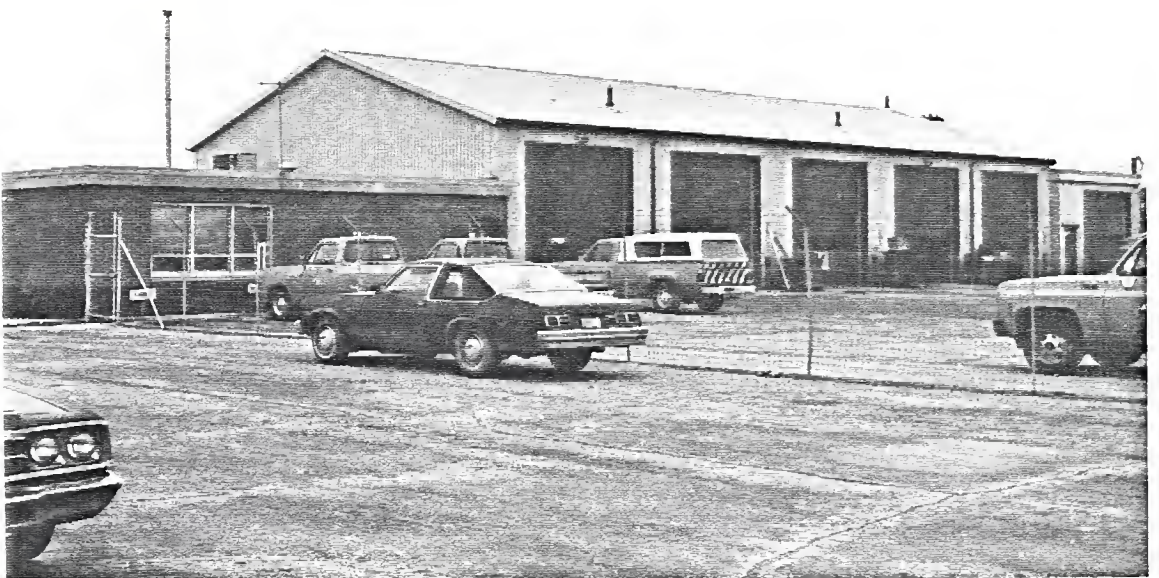
Building Type IV:Regular Block Design

Frame	-	Block wall construction Gabled roof for center section Flat roof for end sections
		Length: 165.8 feet Width: 63 feet
Roof	-	Center section: Insulated metal panels
	-	Outside sections: Concrete slab with a built-up roof.
Wall	-	East section: 8" concrete block and brick veneer
	-	Center section: 12" concrete block
	-	West section: 12" concrete block
	-	Attic walls: Insulated metal siding
Height:	-	Center section: Peak height: 24.5 feet Gutterline height: 16.7 feet
		Outside sections: Flat roof height: 15.7 feet
Major Doors	-	Six overhead doors.
Use	-	Office and maintenance building.
Picture	-	One front view and one rear view on the following page.

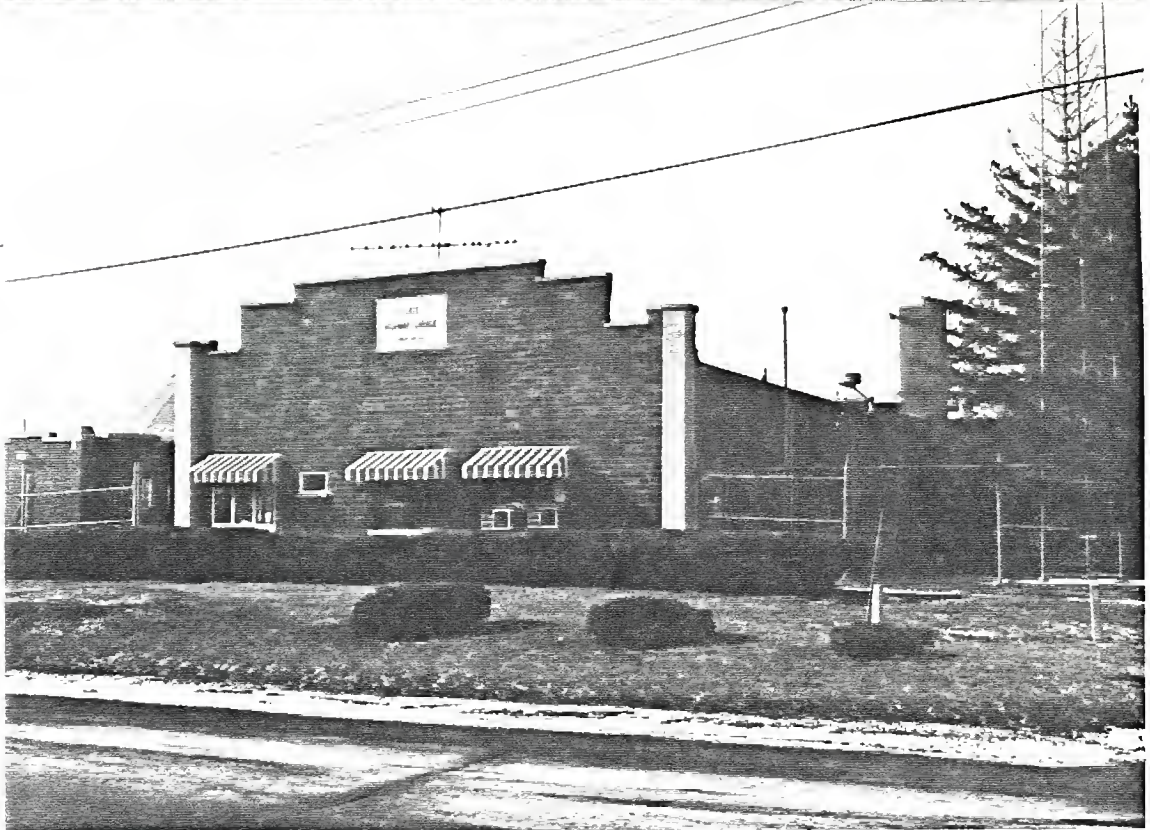
Building Type V: Arched Roof Brick Design

Frame	-	Masonry wall construction with an arch roof.
		Length: 121.8 feet.
		Width: 52.8 feet
Roof	-	Arched steel joist construction with a built-up roof on 2x10 wood purlins.
Wall	-	Brick and concrete pilasters.
Height	-	Varies from 13 feet to 15 feet.
Major Doors	-	Four overhead doors.
Use	-	Sub-District garage.
Picture	-	One front view and one side view on the following page.
